Real time water quality monitoring in Te Waihora

Prepared by Tim Davie, Environment Canterbury, for the 2015 Living Lake Symposium Field Trip, November 18, 2015.

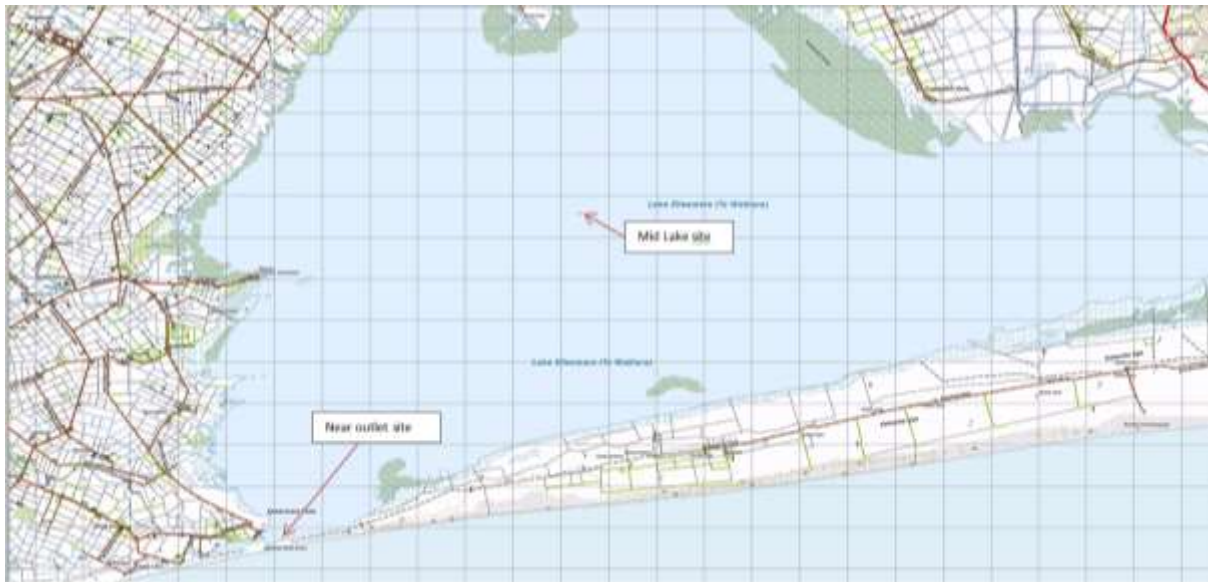
Fig 1: Sites of the water quality monitoring stations

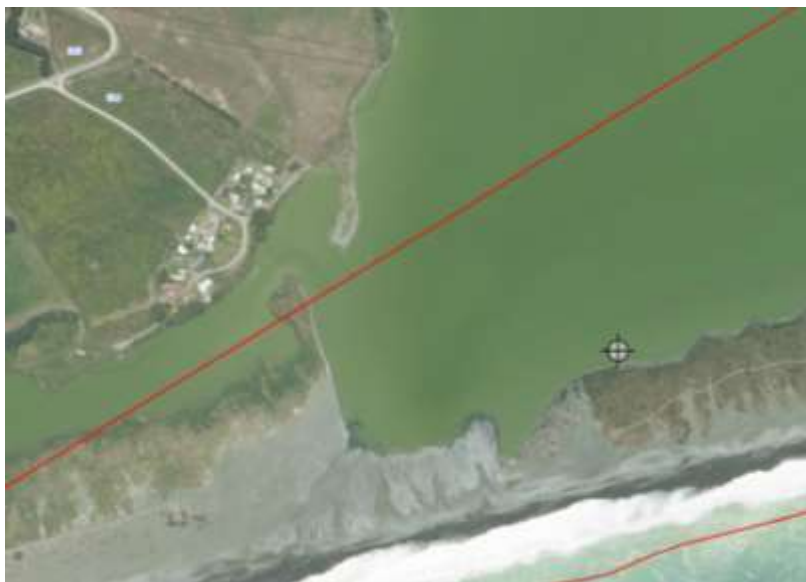
Fig 2: Detail on near outlet site

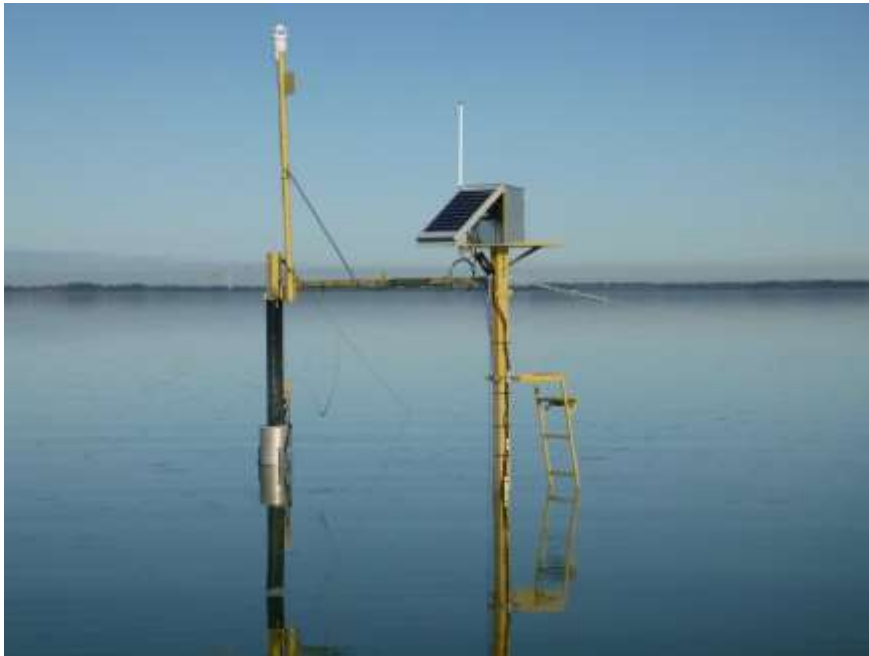
Fig 3: Mid-lake monitoring station

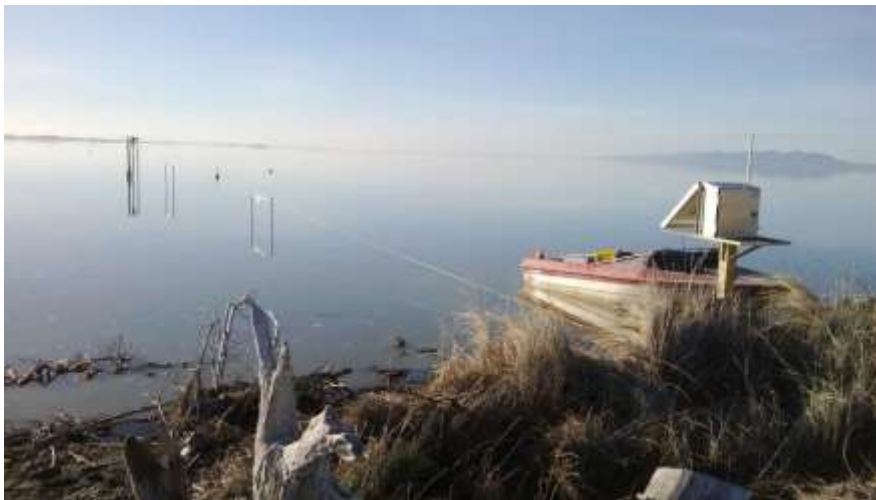
Fig 4: Near outlet monitoring site

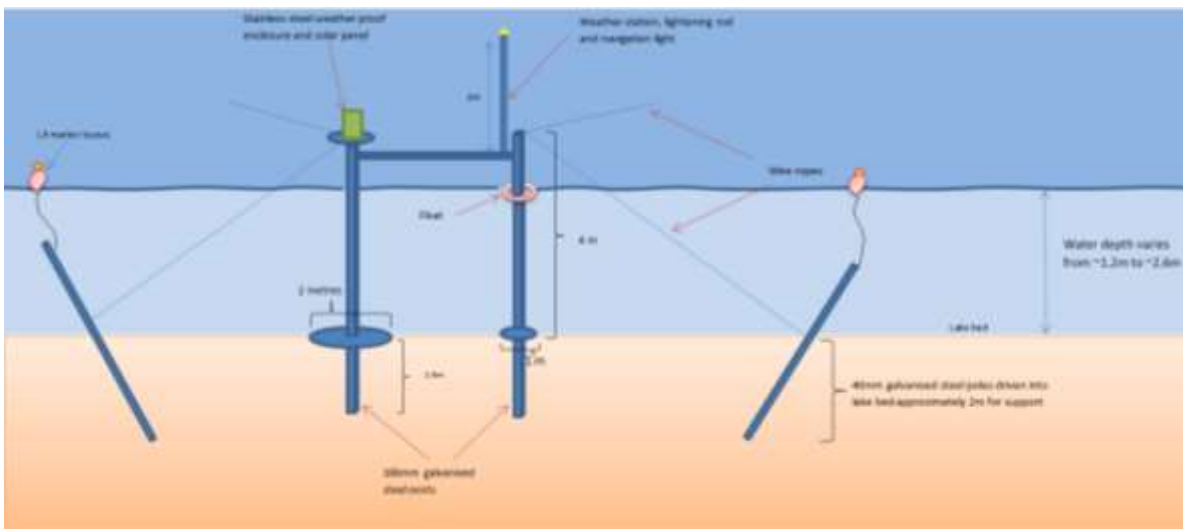
Fig 5: Design of monitoring stations

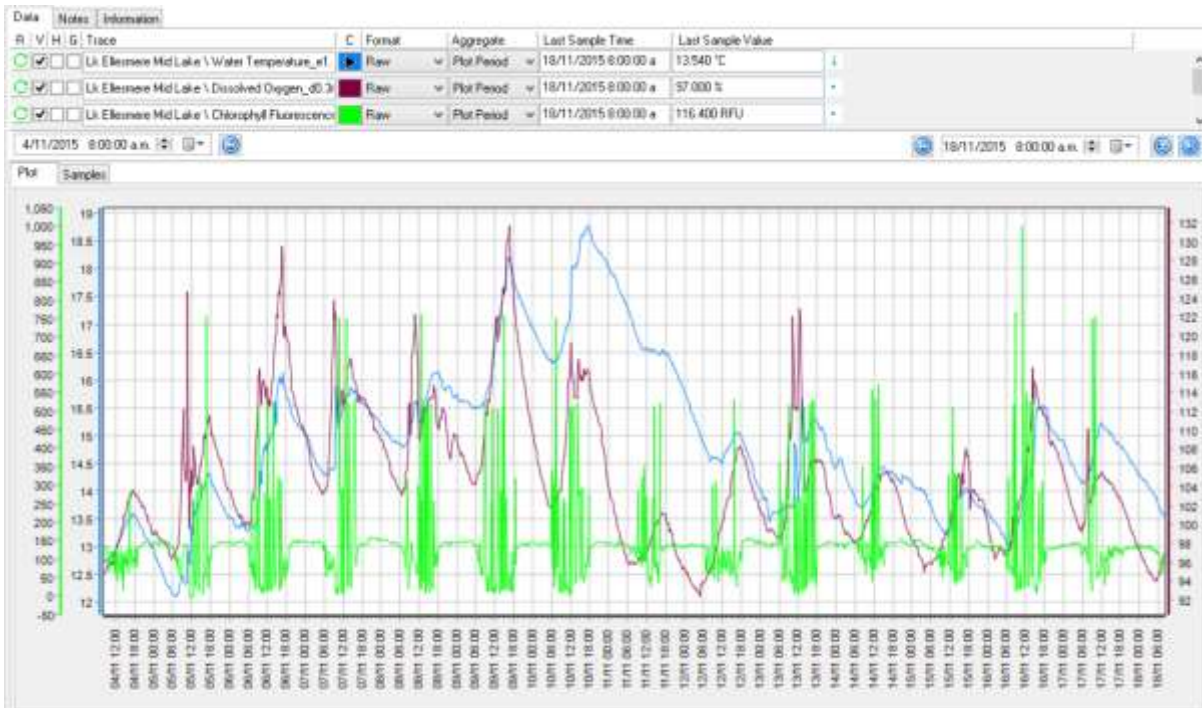
Fig 7: Mid-lake site for past two weeks. Blue line is temperature (lake bottom); Red line is dissolved oxygen; Green line is Chlorophyll a (algal growth). The algal growth during the day is increasing the dissolved oxygen levels above 100% saturation.

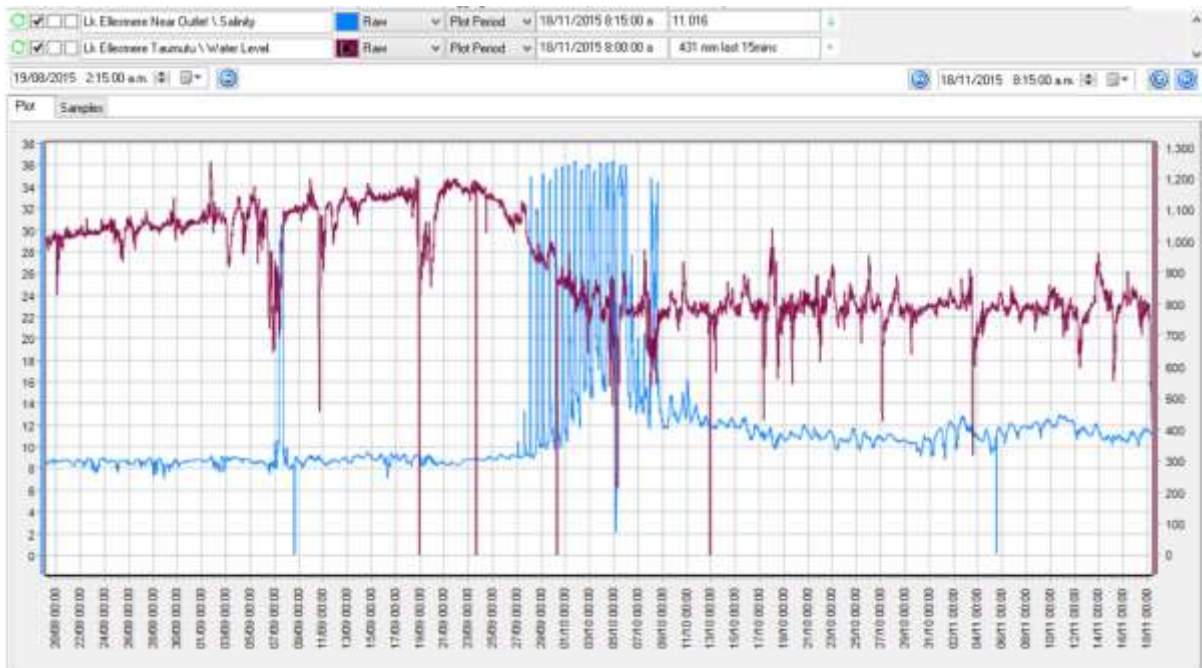
Fig 8: Near outlet site for past three months. Red line is the water level; Blue line is salinity. You can see as the level decreases following the recent opening the salinity increases and then you can see the tidal increases in salinity until the lake closes. You can also see an earlier event where the level has dropped significantly and the salinity increased. This is likely to be a southerly storm with the lake blowing northwards (causing the level to drop by 400 mm) and waves overtopping the barrier.
